Tech-Bond Solutions

Engineering Report – Tech-Patch on steel pipe.

Tech-Bond Solutions TP001 Burst Test Results

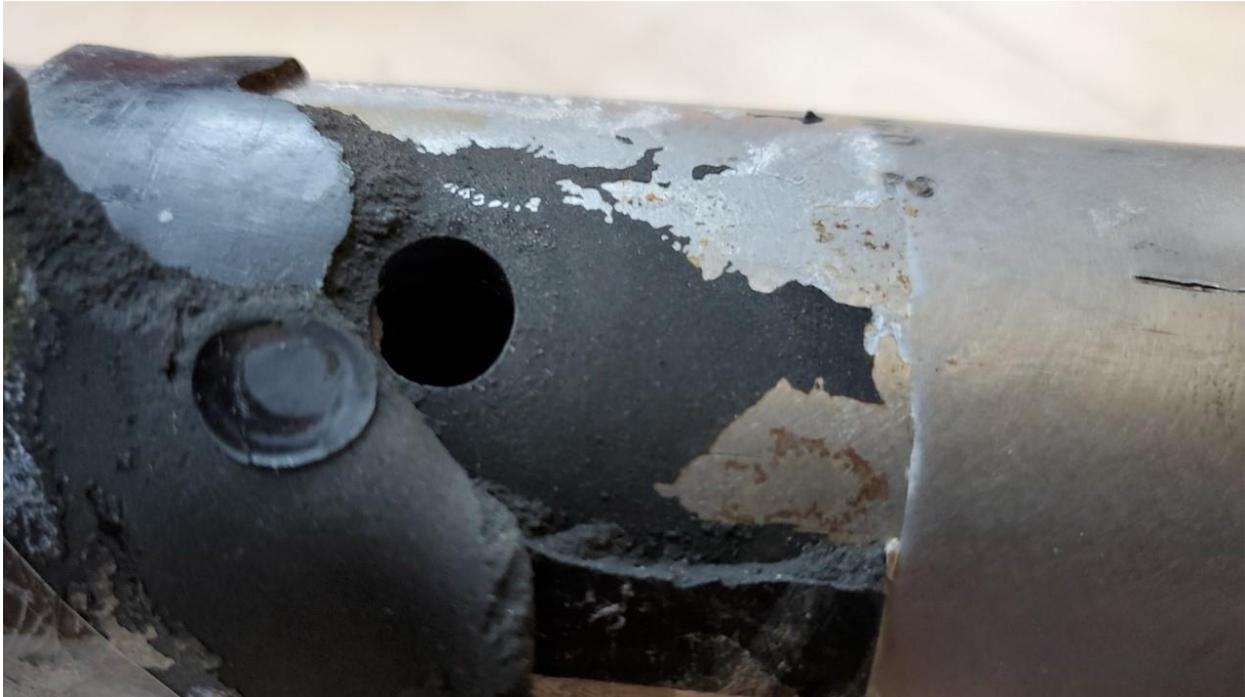
After test picture

The picture reveals that the patch split at 175 psi. There was no failure of the bond. Actually the 175 was a disappointing figure for us. With these results, our XT Tech-Patch will be rated to repair holes and cracks up to 120 psi. That rating will qualify the Patch for most repairs withing the water industry.

- ▶ The pipe was first fitted with sealant and caps on either end to ensure no leaks
- ▶ The pipe test PSI increase was at a rate of 3-5 PSI per second
- ▶ First test was to 50 PSI for 3 minutes which was held with no pressure drop
- ▶ Second test was an increase from 50 PSI to 100 PSI for 3 minutes which it held with no pressure drop
- ▶ Third test was an increase from 100 PSI to 150 PSI for 3 minutes which was held with no pressure drop
- ▶ Fourth test was an increase from 150 PSI to 200 PSI for 3 minutes. During the increase, at a gradual rate of 3-5 PSI per second, the patch let go and burst at exactly 175 PSI
- ▶ The patch split, not because of the bond, but due to the patch material. After further investigation it is apparent that the bond was intact after disassembly.
- ▶ The patch material was responsible for the burst at 175 PSI. Bond held together throughout the trial.
